Character Appraisal  
March 2019

# St. Michael's Church Conservation Area

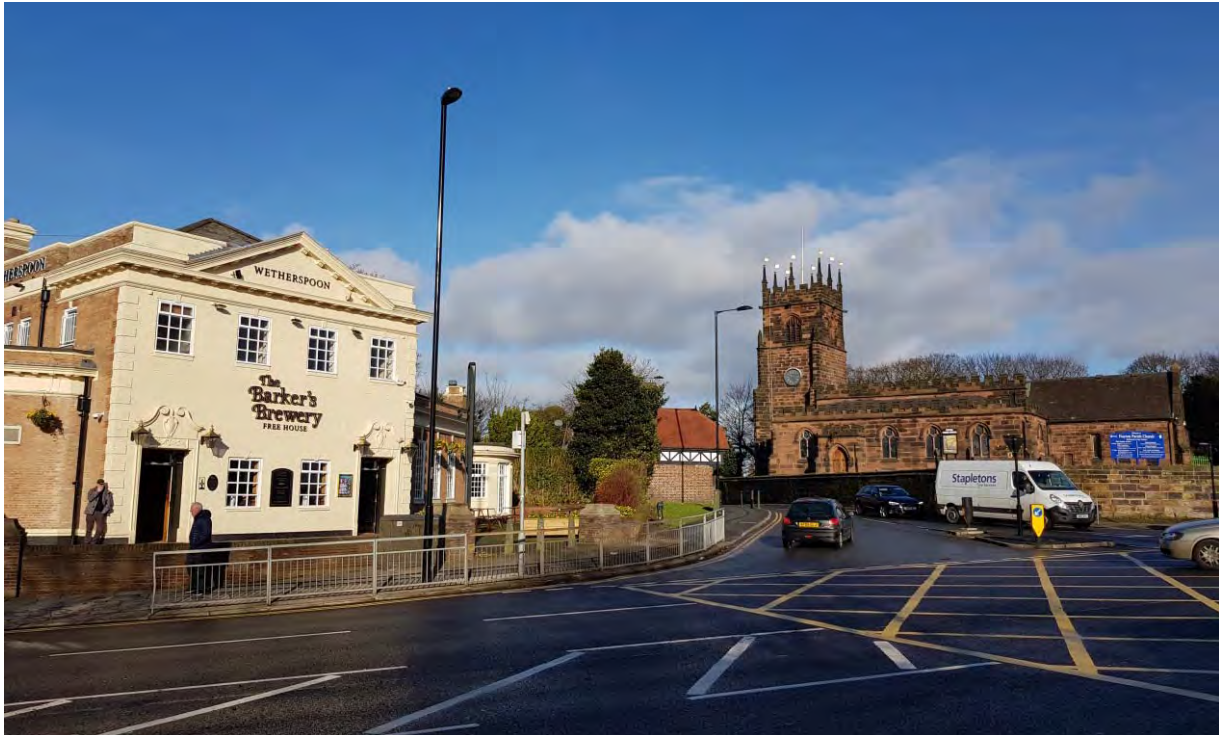
Figure 9 - St. Michael's Church and The Barker's Brewery Pub, the red roofed Blue Bell Cottages can be glimpsed.

Barkers Brewery is a large 1936 'improved' roadhouse public house. Barkers Brewery was originally built by Peter Walker Ltd as a modern replacement for the much older "Rose and Crown" public house, which occupied a building opposite and was demolished as part of the Archway Road expansion. It is in a symmetrical neo-Georgian style and has a prominent position at the corner of Bluebell Lane and Huyton Lane, set back from the road. It is highly visible when approaching the junction. This is a characteristic setting for an 'improved' pub, the philosophy of which was to modernise and 'improve' the old Victorian public house to make it a more welcoming and cleaner design. 'Improved' public houses were typically built on large plots of land with car-parking facilities provided for motorists, they had large spacious rooms, kitchen and restaurant facilities.

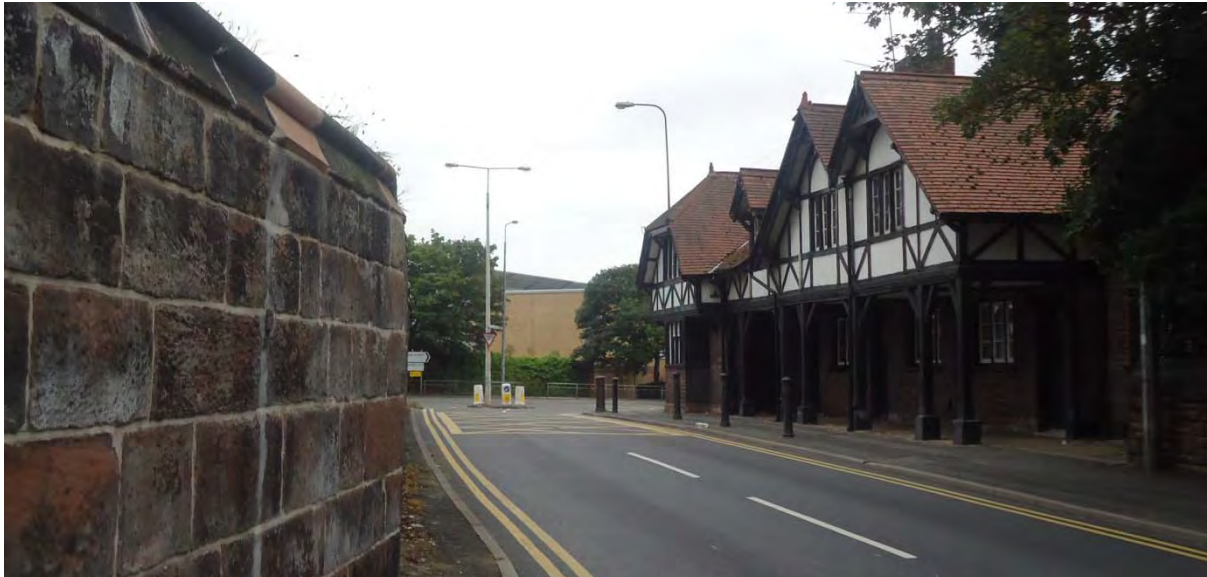
Adjacent to the Barkers' Brewery are Blue Bell Cottages, 112-118 Blue Bell Lane. These are notable for their mock-Tudor appearance with a jettied upper floor, which is unique in Knowsley. The

precise date of this building is unknown, however, it appears there has been a building on this site following the same footprint since at least the 1850s. It is likely that the current building is a late 19<sup>th</sup> Century re-development of an earlier building. The half-timbered building offers a striking focal point when approaching from Huyton Lane and again when travelling up Blue Bell Lane. Because of its jettied first storey and the relative narrowness of Blue Bell Lane at this point, it is a tangible indicator of the proximity buildings were to the churchyard before the redevelopment of the area in the 1960s/70s.

Figure 10 – Approaching Blue Bell Cottages on Blue Bell Lane looking towards Archway Road and the large sandstone wall of St. Michael’s Church.

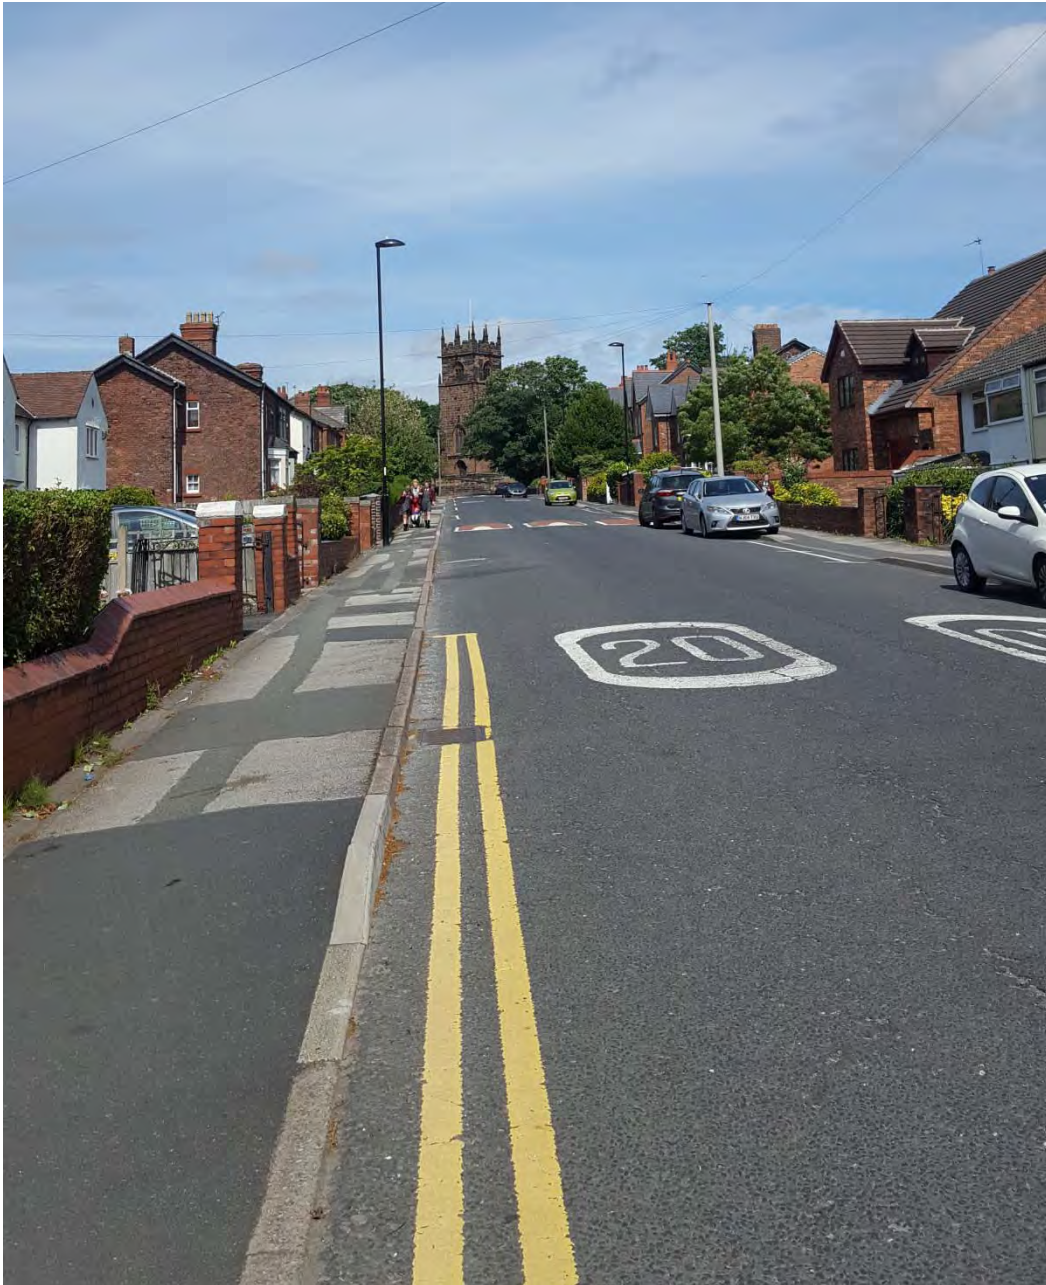
Figure 11 - This view along Stanley Road shows the prominence of the church, but also the negative impact the road markings and speed cushions have on the appearance of the area.

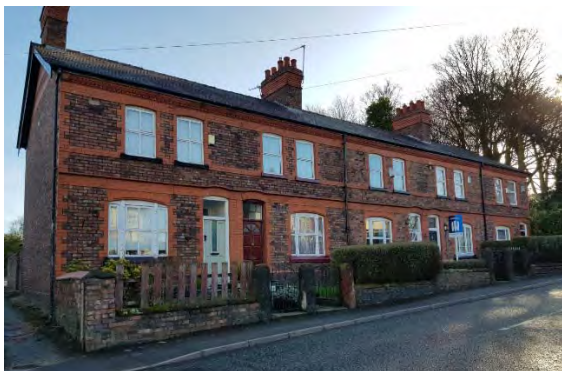
Figure 13 - Stanley Terrace on Blue Bell Lane

Where original terracotta pots are still present, they are of a traditional form but of various ages and styles suggesting historic ad-hoc replacements when needed. Stanley Terrace appears to be the only terrace with a near complete set of original chimney pots, which adds considerably to its regular appearance and attractive qualities.

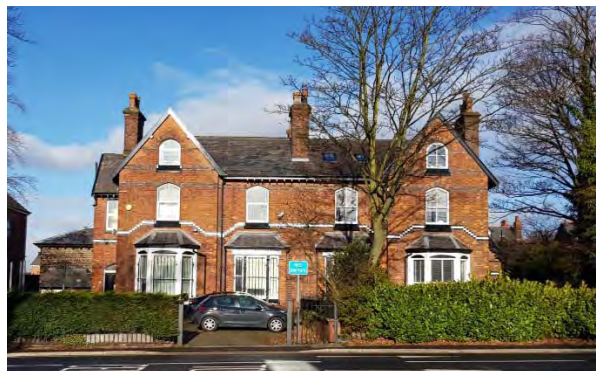
Figure 14 - Later 19th Century Semi-Detached Villas on Archway Road

These range from simple early semi-detached cottages to grander villas. The later villas are typified by strong front facing gables and more ornate architectural details such as gothic elements and decorative timberwork. Pairs were originally symmetrical but individual changes to finishes, alterations and extensions have broken up the symmetry and disrupted the rhythm of the street.

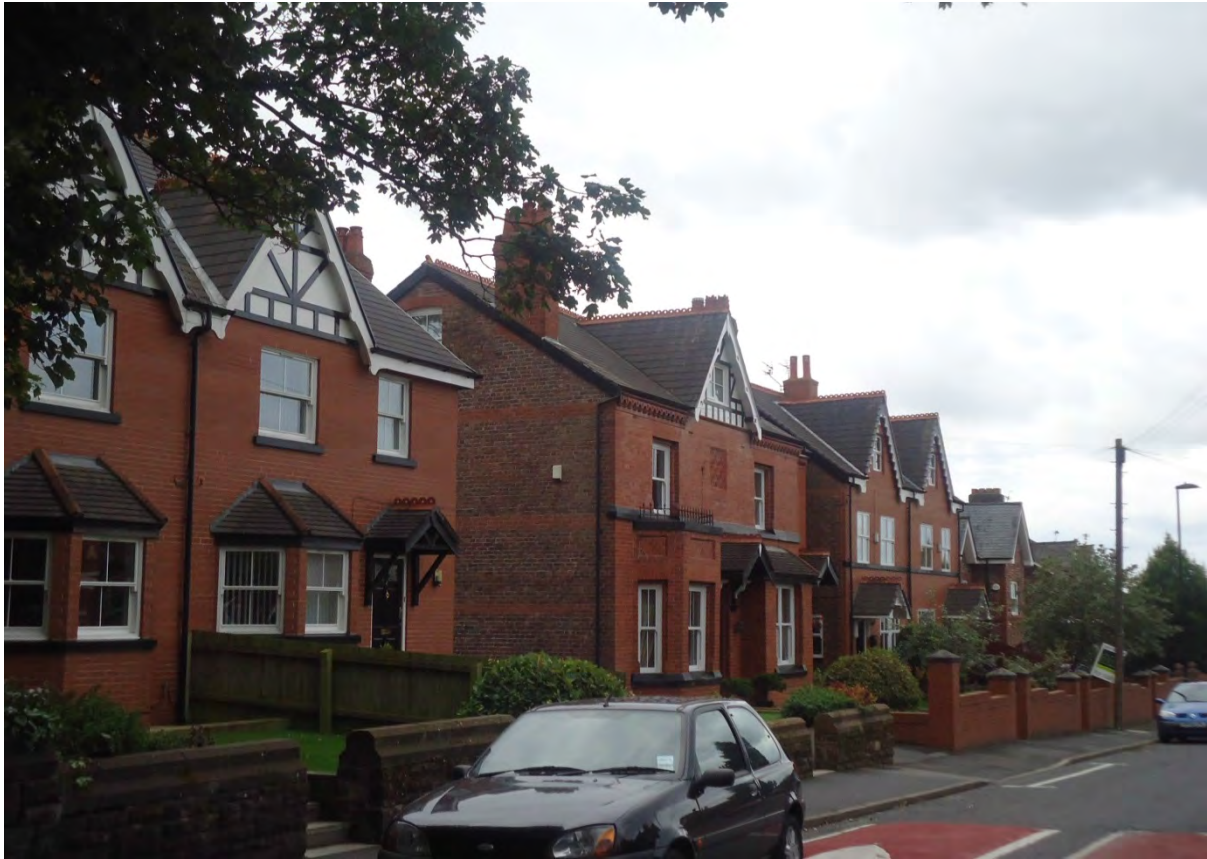
**Figure 15 - Nos 2-8 Stanley Road. Two 21st Century Semi-Detached Pairs Either Side a 19th Century Dwelling, Illustrating Differences in Window Details and Plot Spacing.**

There has been some rebuilding and repointing to some elevations, however occasionally replacement bricks have failed to match existing and these detract from the visual appearance and authenticity of the scheme.

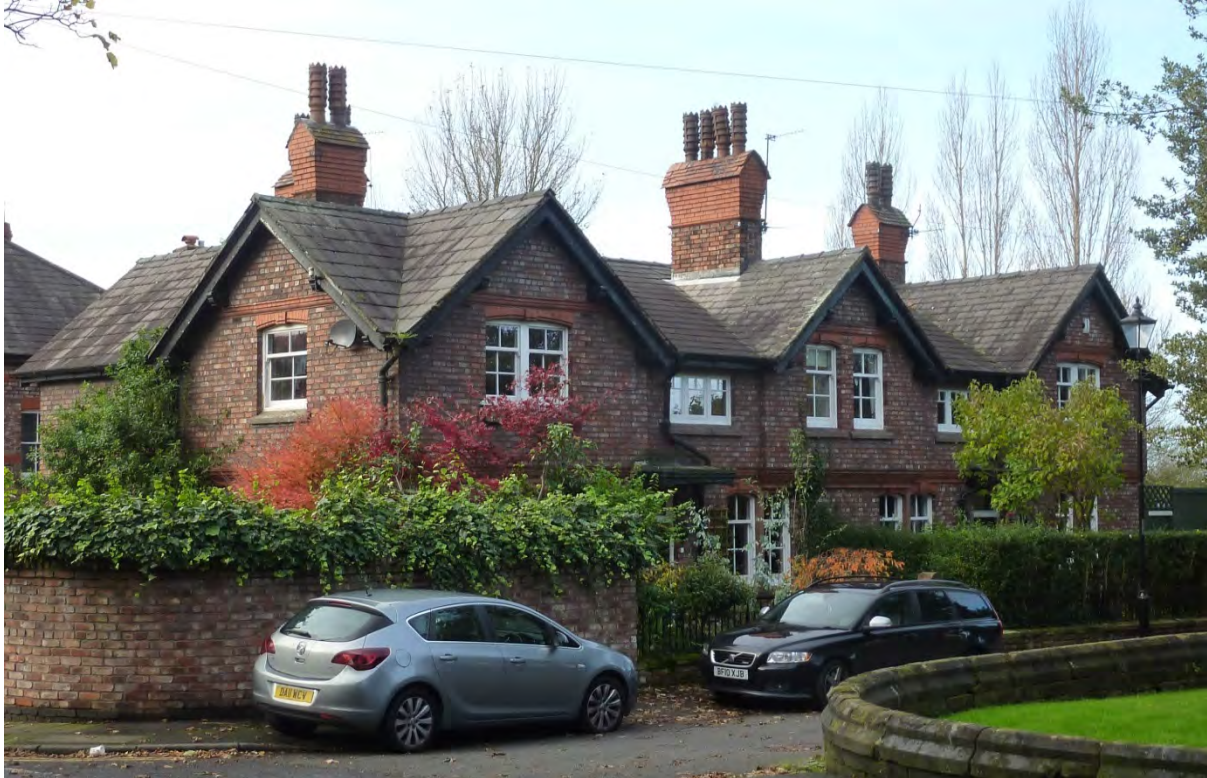
Figure 16 - Nos 1-3 Stanley Road, Showing Distinctive Chimneys, Brickwork and Prominent Gables

Chimneys are distinctive elements of the conservation area and are generally large brick stacks with a range of details and decoration. The earlier properties have plainer deeper stacks with rows of chimney pots whilst later building have more ornate and detailed features including corbelled layers with clustered pots, reflecting the architectural style of the host property. 1&3 Stanley Road have expressive chimneys consisting of gabled stacks with multiple vented pots – a form often seen in the borough and probably associated with the estate architect of Knowsley Hall.

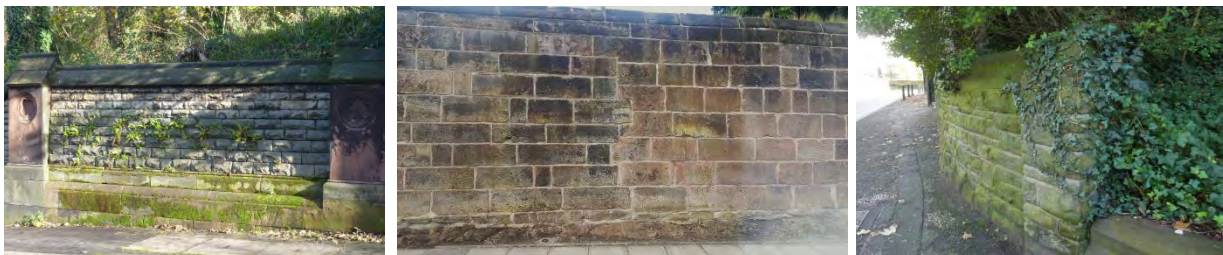
Sandstone is a prominent material in the conservation area, primarily used in walls. The most prominent example is St. Michael's Church and the Churchyard wall, which faces onto Huyton Lane and Blue Bell Lane. It is a long and high wall sitting on an outcrop of sandstone. It has been refaced or rebuilt in certain areas, thereby adding to the interest of the whole. Local sandstone slab walls are also a historic feature of this area.

Figure 18 – Distinctive sandstone walls add to the character of the area.

Sandstone masonry and brick walls in the area also require regular upkeep and some walls are in need of repair and repointing. Repointing should be undertaken with an appropriate mortar of matching colour and texture. Cement based mortars are usually inappropriate as they are inflexible and direct evaporation through the softer masonry, leading to faster erosion.

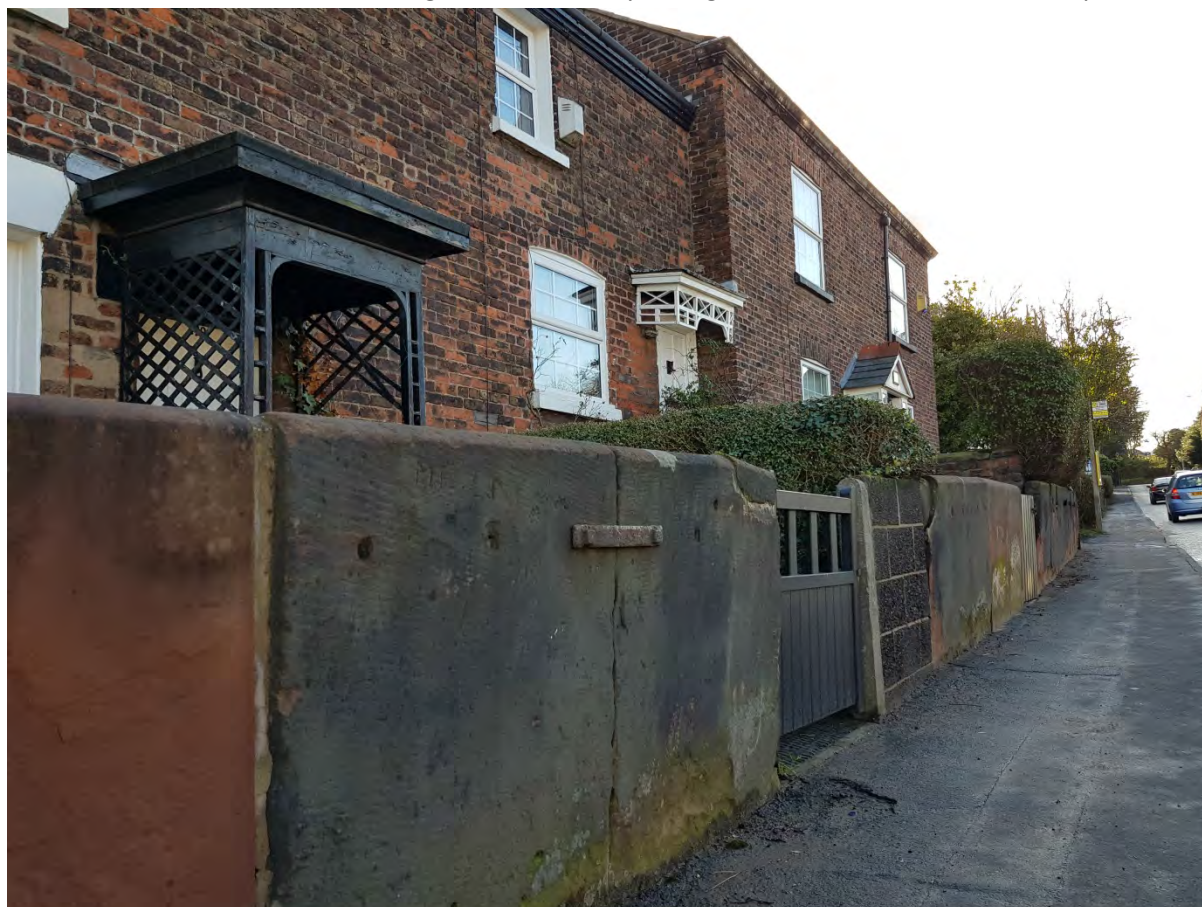
**Figure 19 - Blue Bell Lane Showing Stone-Slab Walls with Modern Insertions and Irregular Plot Sizes and Building Lines of this Early Terrace.**

Sandstone slab walls, with the stone rounded at the top and placed into the ground lengthwise are a feature on Blue Bell Lane, adjacent stones are joined with iron staples. Many of these staples are now missing and those that remain are rusted, but the mounting holes can still be seen. They are a form that has been used for centuries, and was once more common in the borough. There have clearly been more modern replacements which lack the iron staples but these are of a good quality natural stone. There is breezeblock replacement which is jarring and uncharacteristic

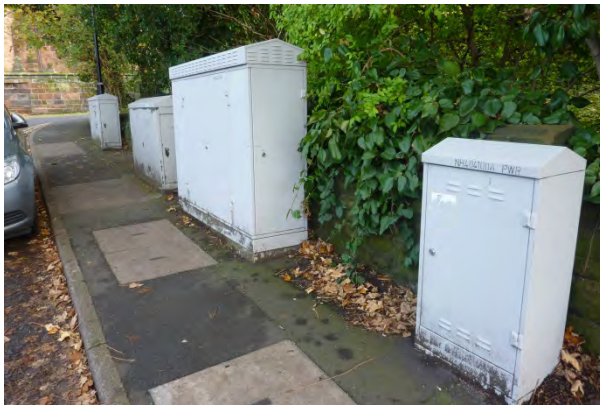
Figure 20 - Utility cabinets at Stanley Road are intrusive and jarring.

The infrastructure associated with various utilities have a noticeable impact on the character and appearance of the conservation area. Cabinets set on the highway are mixed in colour, some being dark green and others in pale grey. There is evidence of graffiti and flyposting on these boxes. One particular area of note is the collection of four cabinets at the top of Stanley Road opposite the village green. They are all of large size, closely concentrated and of a pale grey colour. They prove particularly jarring in this prominent location.

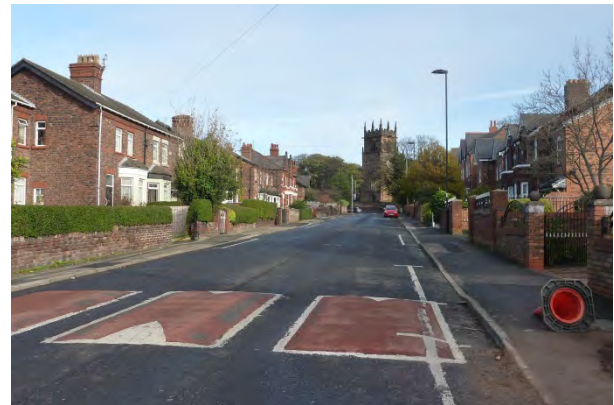
Figure 21 - Speed cushions are of unsympathetic colours and visually disruptive.

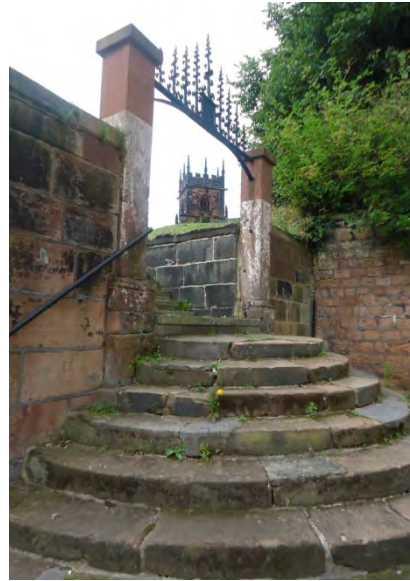
The entrance to the church on the north east corner consists of a wrought iron overthrow with 9 decorative finials set inside Tuscan style gateposts. This overthrow is in reasonable condition. It has a central panel reading: "R.L/J.S/Th.Bs/C.W/1765] The gateway previously contained gates but these were lost before it was listed

Figure 22 – Entrance Gate to the North-East Corner of the Churchyard.

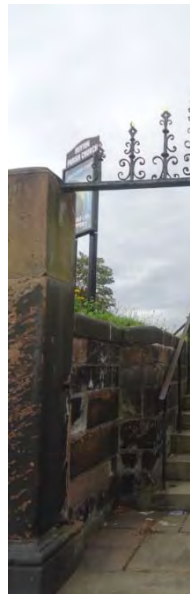
Figure 23 - The Entrance Gateway to the South of the Churchyard

The gateway consists of an iron overthrow fixed into sandstone columns with nine decorative finials and a central panel in gold painted "R.L/J.S/T.B/C.Wn/1765" and so is not identical to that associated with the north east entrance. The tops of the columns are modern replacements and the finials have parts of their decorative scrollwork missing. The ironwork shows signs of deterioration.

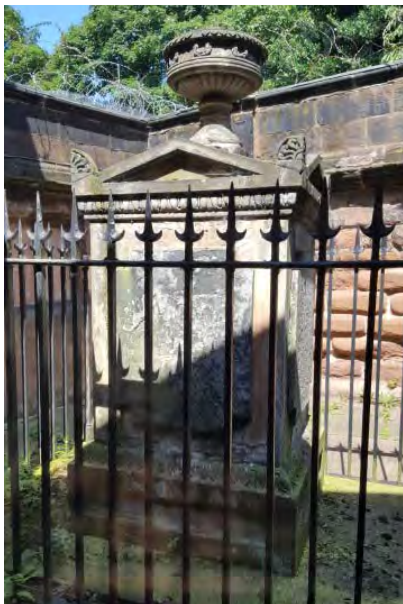
This is a pedestal monument possibly from the early 19<sup>th</sup> Century. There are panels on each side that have weathered to the point they are illegible.

The monument is highly decorated with detailed carvings and an urn on top and cast iron railings with decorative heads surround it. It is located in a fenced off area of the churchyard which means it is little appreciated.

Figure 24 – Monument within Churchyard

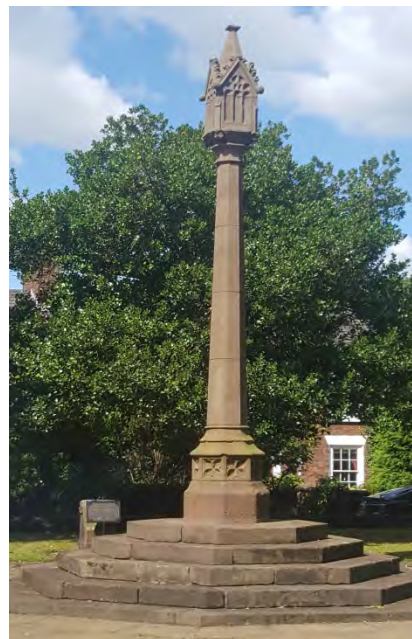
The cross is an 1897 replacement for an earlier 1819 cross. The original cross was designed by Thomas Rickman. This was replaced in the mid-19<sup>th</sup> century with an ionic column with a pointed floral finial.

Figure 25 – The Village Cross

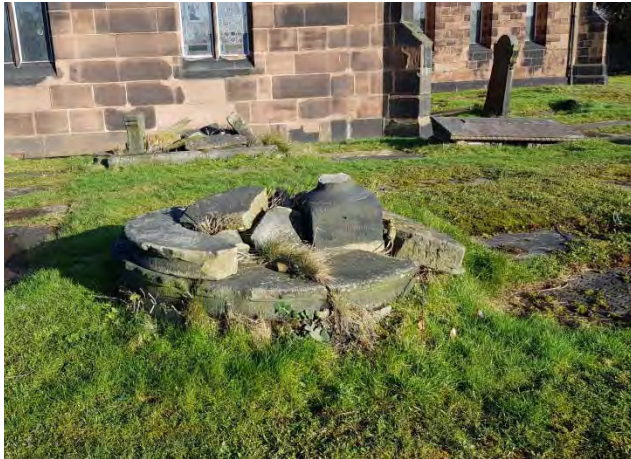
Grave monuments in the churchyard are in a poor state and the decorative sundial that once existed is now in a ruinous state.

Figure 26 - The remains of the sundial.

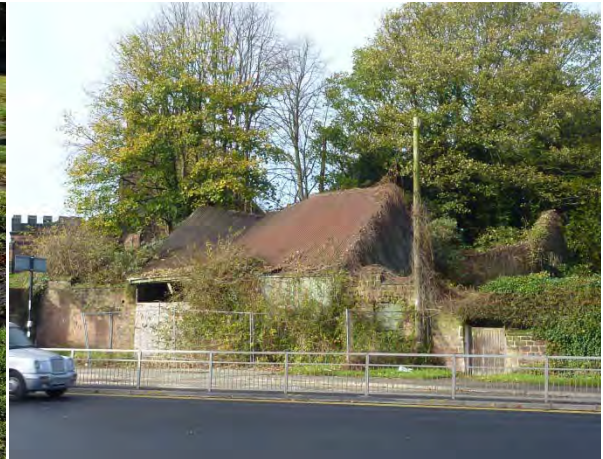
Figure 27 - The Old Fire Station/Hearse House

This iron roof is now the major part of the site that is visible from the public highway and is in poor condition. This deteriorating roof is visually harmful in itself but also has the negative visual effect, of hiding the Victorian building. It is also clear that at least part of the roof of the historic building has also collapsed. A mixture of block and mesh and ad hoc fencing now surrounds the building.
